FINAL REPORT

**The City College of New York (CCNY)
Campus Energy Assessment
*JDE #2841089999***

January 2010

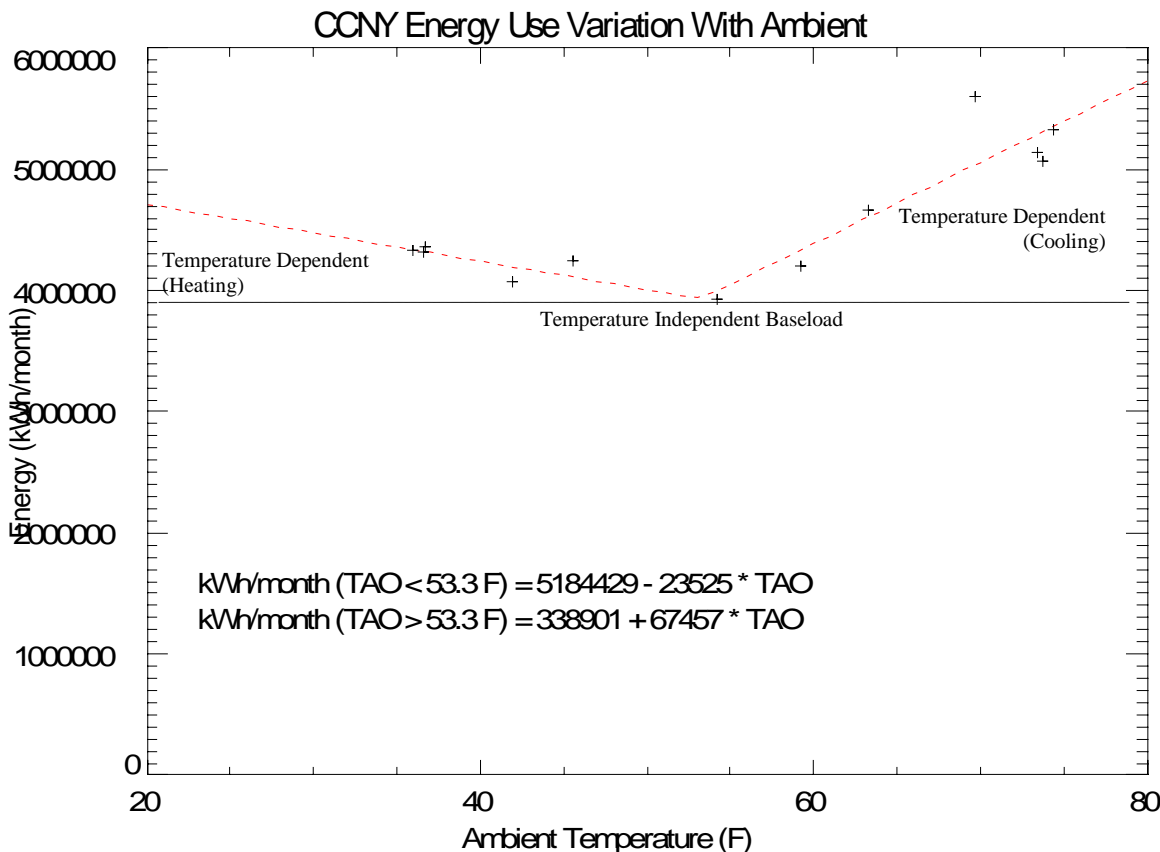
Figure 2.2-2. Variation of Energy Consumption with Ambient Temperature – Entire CCNY Campus

Figure 2.2-3 displays the variation in energy consumption with ambient temperature. The trend displays a classic change point model, with energy increasing as ambient temperature moves away from the thermal balance temperature of 53°F. Below 53°F, the monthly energy use increases at a rate of 23,525 kWh/month/°F typically due to increases in exterior and interior lighting loads (as the decrease in daylight duration is coincident with the decrease in ambient temperature). Other causes for this trend are increases in pump and fan runtime associated with heating operations.

The trend also indicates that 3.9 million kWh/month, or 47.2 million kWh/year, is temperature independent energy consumption (lights, equipment, and constant duty motors for example). This is approximately 85% of the total campus energy consumption. Energy consumption above the thermal balance point totals 6.4 million kWh/year, or 12% of the total campus energy consumption. Energy consumption below the thermal balance point totals 1.7 million kWh/year, or 3% of the total campus energy consumption.

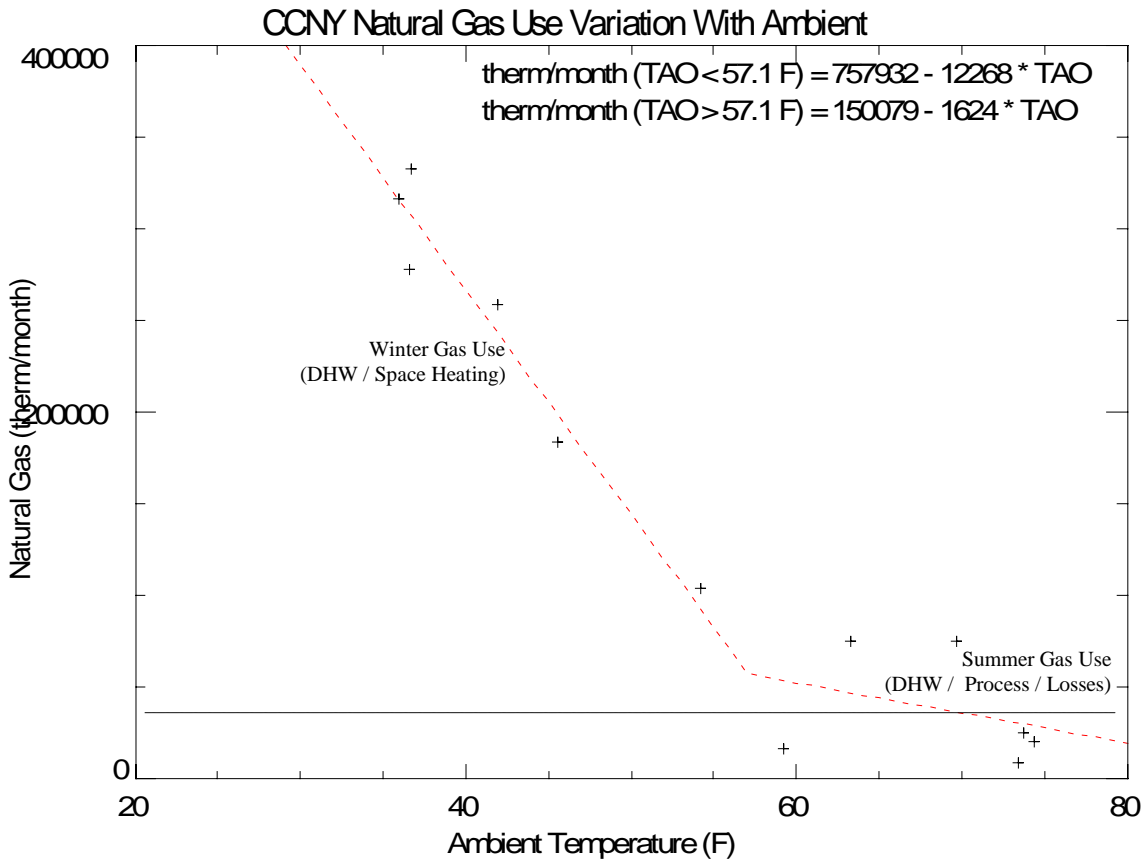
Figure 2.2-3. Variation of Natural Gas Consumption with Ambient Temperature – Entire CCNY Campus

A similar analysis was performed on the natural gas consumption for the campus (Figure 2.2-4). The gas use trend again indicated a change-point relation with ambient temperature. The trend below the thermal balance point of 57°F is indicative of the gas use for space heating, while the trend above the

The temperature independent natural gas baseload totaled 446,000 therm/year, or 26% of the annual natural gas consumption. The temperature dependant portion of the natural gas consumption totaled 1.25 million therm/year, or 74% of the annual consumption.

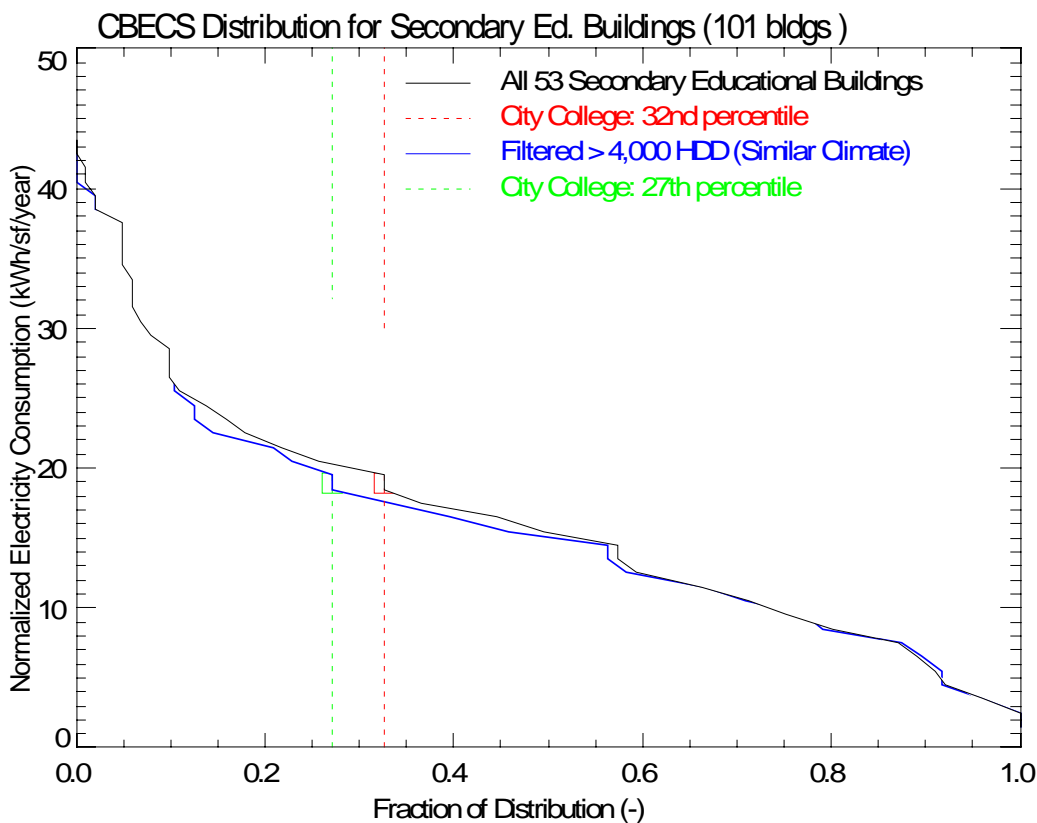
Figure 2.2-4. CBECS Distribution for Floor Area Normalized Electricity Consumption in Secondary Education Buildings

As a whole, CCNY ranked between 27th to 32nd percentile on normalized electricity consumption, and 16th to 24th percentile on normalized natural gas consumption. The variation in ranking was due to the inclusion of the climate-based constraint, and resulting smaller sample size. These generally lower rankings indicate that there is reasonably good potential for savings in both electricity and natural gas consumption at CCNY.

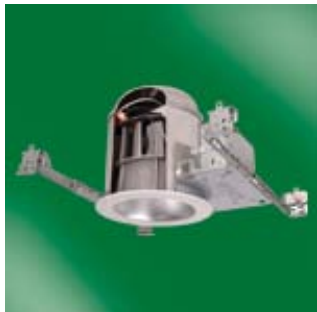
Cooper HALO LED 6-inch Downlight

- Total Watts: 14 W
- Lamp Life: 50,000 hours
- Initial Cost \$144
- LED Module Cost (replacement) \$92
- Energy Cost over 15 years with 4,000 hours/year operation and \$0.11/kWh: \$92
- Lamp Cost over 15 years: \$184
- Total Cost over 15 years: \$276

The economics of retrofitting existing lighting with an ENERGY STAR approved LED fixture was examined. The LED fixture considered was a Cooper Lighting HALO LED recessed canister downlight, and was compared to a comparable compact fluorescent fixture (see Figure 6.3-7). Given the high replacement cost of the LED modules (at present day costs), these LED lamps are not cost effective given a 15 year fixture life.

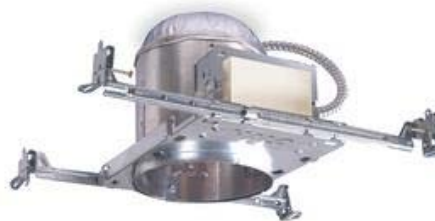
Conventional Compact Fluorescent Downlight

- Total Watts: 26 W
- Lamp Life: 15,000 hours
- Initial Cost \$115
- Replacement Lamp Cost: \$8
- Energy Cost over 15 years with 4,000 hours/year operation and \$0.11/kWh: \$172
- Lamp Cost over 15 years: \$32
- Total Cost over 15 years: \$204

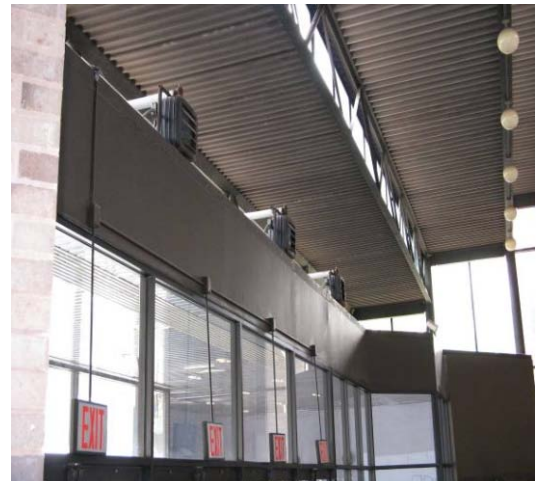
Large amounts of single-pane glass and infiltration in the entry result in a need for the unit heaters shown above.

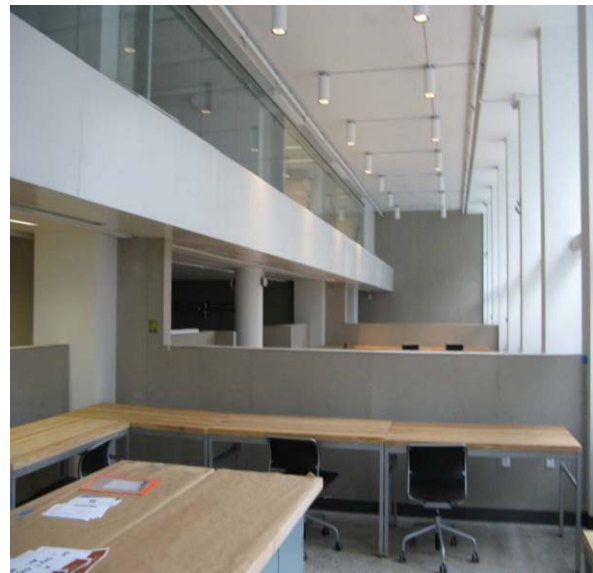
Lights adjacent to windows could be off during daylight hours.

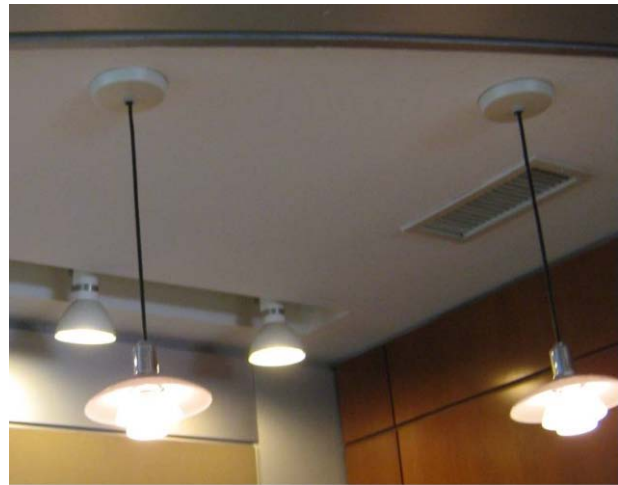
Some display areas are over-lite.

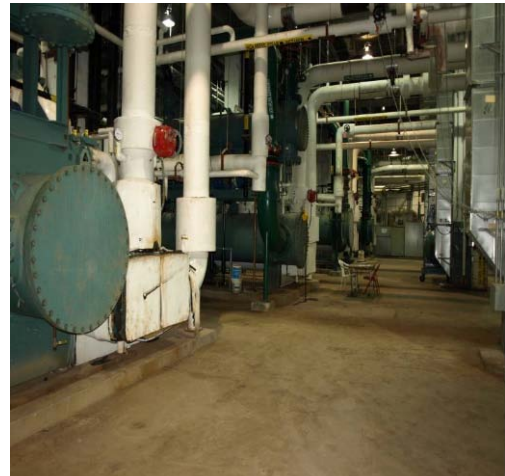
Because of failing building controls throughout the campus, the chilled water plant is being forced to provide too large of a flow in its secondary chilled water loop. As a result, the secondary chilled water loop is overcoming the primary chilled water flow, resulting in mixing. So, despite making 42 degree F chilled water, only 45 or 46 degree F chilled water is leaving the plant. In addition to being a poor use of energy, this elevated chilled water temperature is also the cause of poor dehumidification throughout the campus, which is compounded by the lack of re-heat coils.

The newly renovated chiller plant.

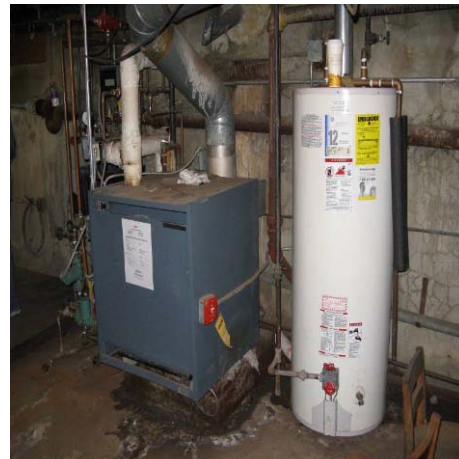
No deficiencies noted.

Boiler and water heater

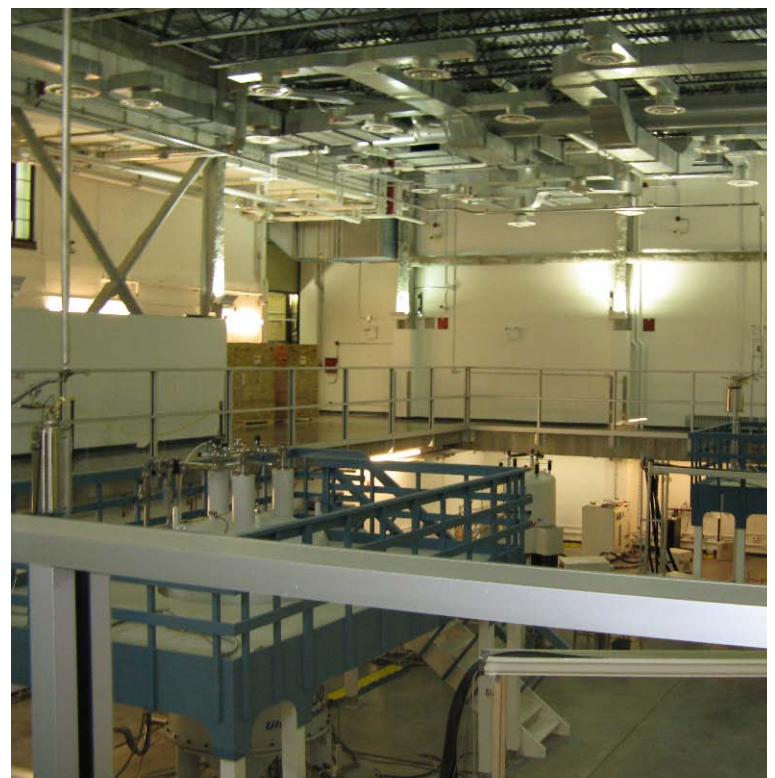
The catwalk overlooking the NMR's shows a very well maintained facility.
